Keith Abbott - Energy  
Audits and Consulting

**ENERGY ANALYSIS - WARWICK ELEMENTARY SCHOOL**

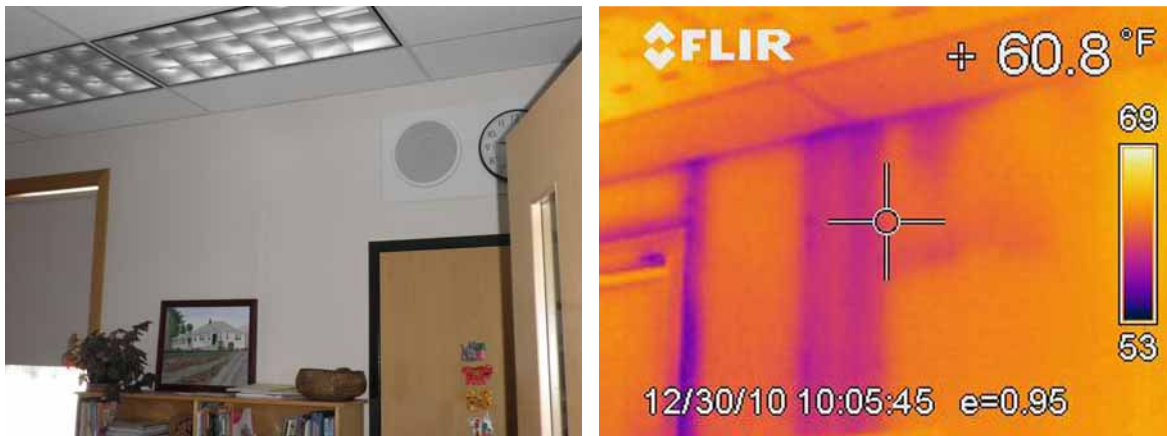
The above images were in one of the classrooms at the Warwick School. Note the cold/dark area along the interior wall. The top wall plate is open to the above cold attic space.

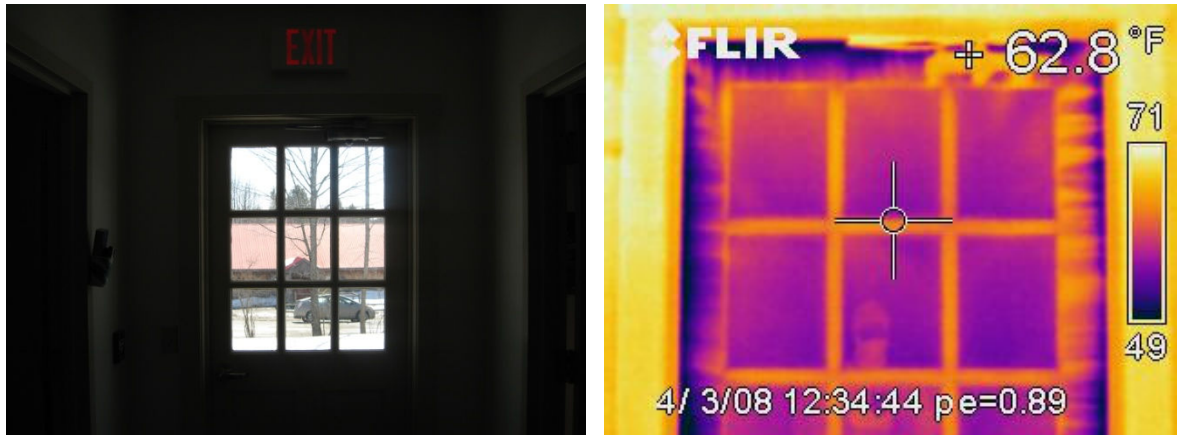
A poorly sealed exterior door provides a perfect example of how air leaks to the interior appear in an infrared image. Note the dark wispy pattern around the door perimeter. These images were taken while the blower door was operating. Cold air drawn into the building during depressurization can be easily detected by the infrared camera.

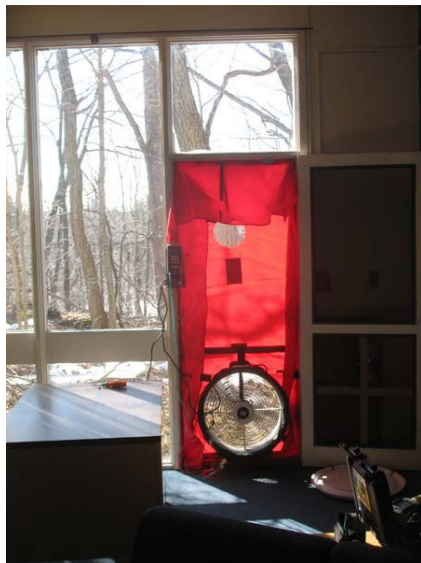
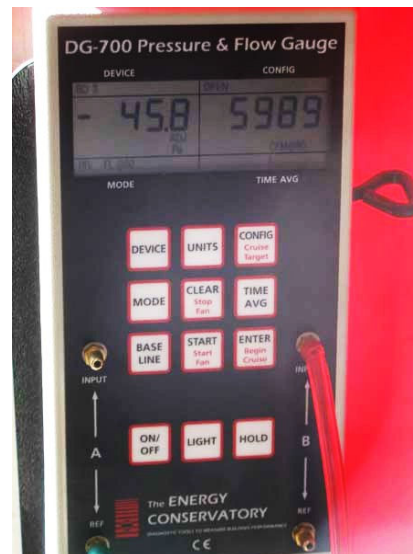
The blower door set up and operating (left photo), and the digital manometer recording building pressure relative to the outside, and air flow in cfm through the fan.

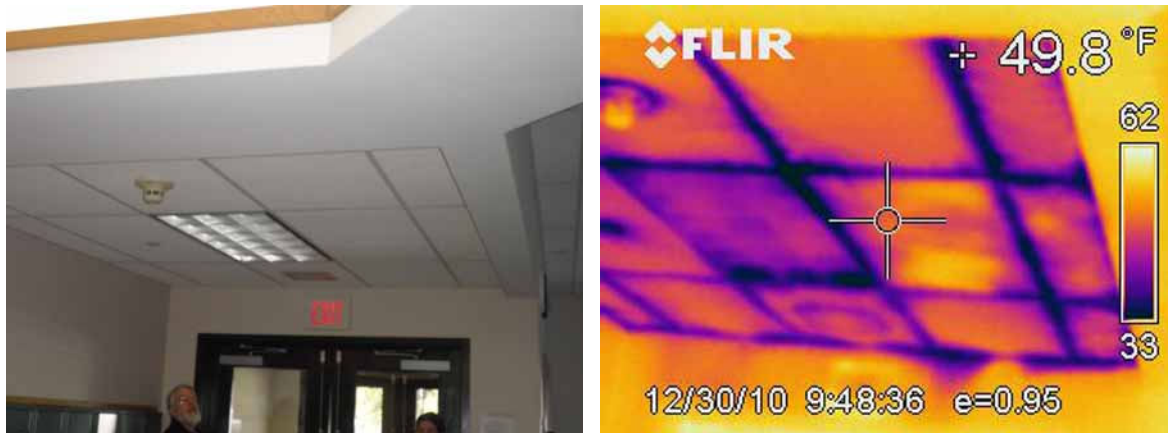
This ceiling area just in front of the west side entry is connected to the outside through the attic. The blower door is pulling cold air from the attic area into the building through the gaps and cracks around the ceiling tiles and light.

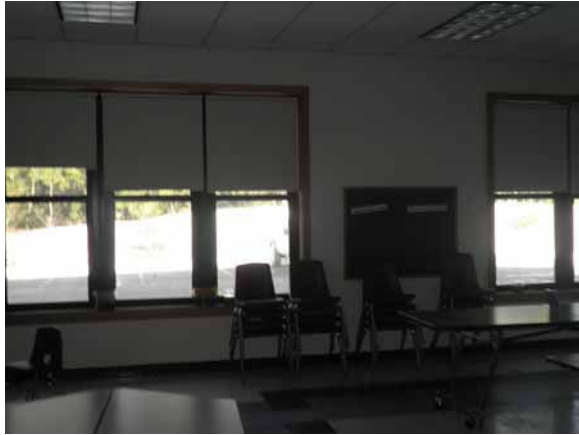
Although the windows have a special coating that reflects some of the heat back into the room, drawing the shades in the evening will conserve more energy.

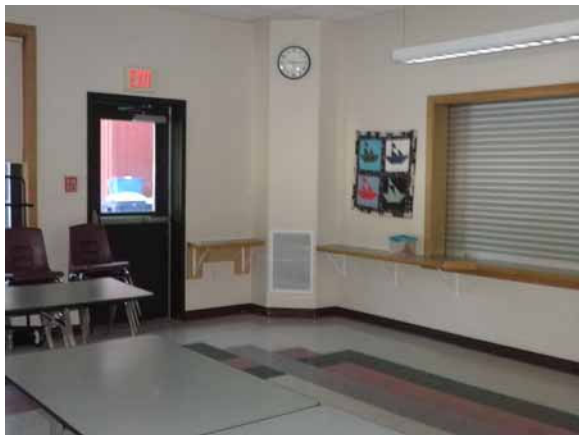
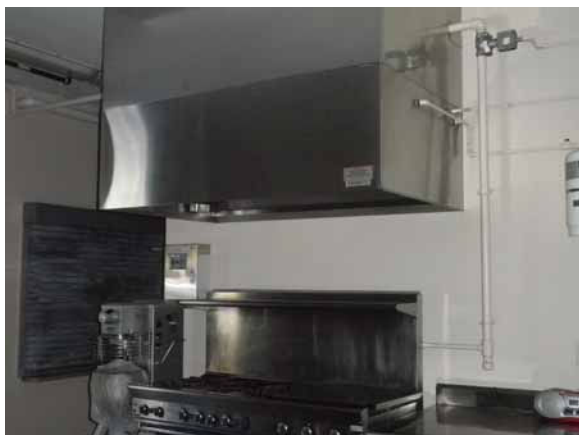
The range hood is connected to the outside via the ductwork that exhausts the fumes and moisture from cooking to the outside. A simple vent baffle can be installed to reduce heat loss through the range hood.

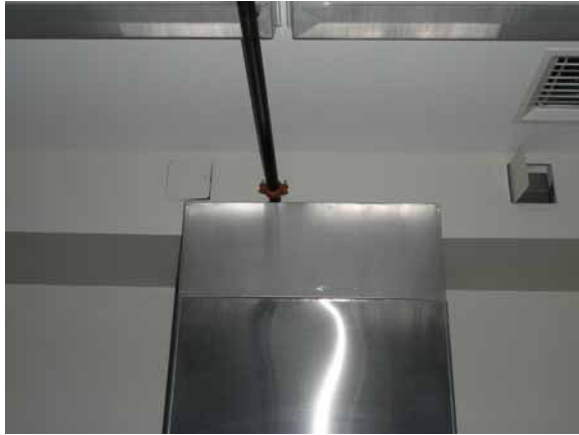
There is a significant air leak in this soffit behind the dishwasher.

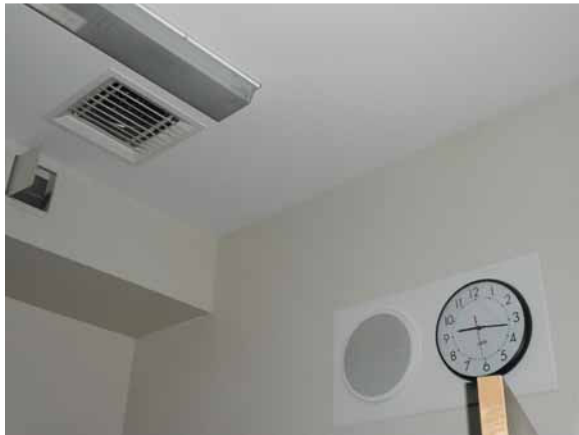
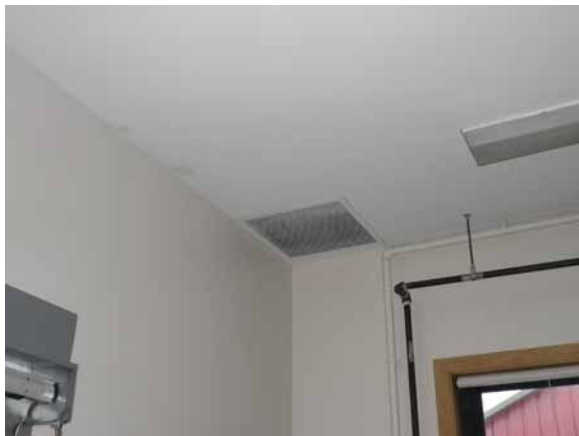
## Energy Analysis - Warwick Elementary School

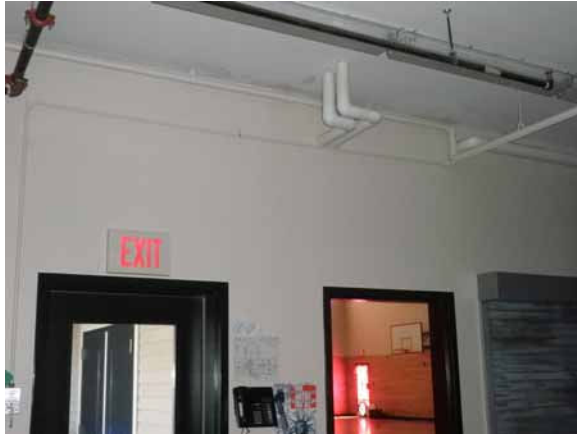
The stud bay between the exterior door and the door that enters the gym through the kitchen is missing insulation. The gym wall meets the main building at this point. Such junction points are common air leak passageways.

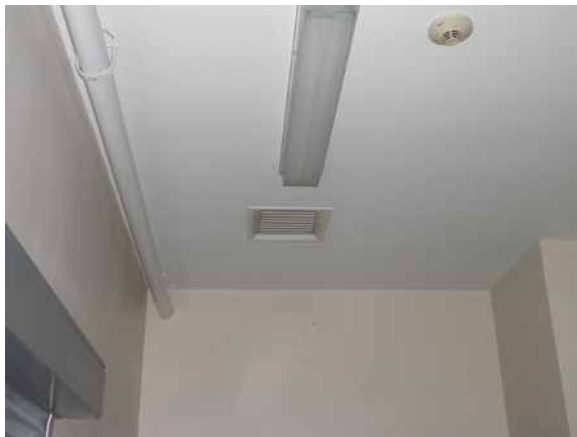
This supply duct and other holes in the ceiling like it need to be sealed with either caulking and/or expandable foam when installed to ensure an airtight seal.

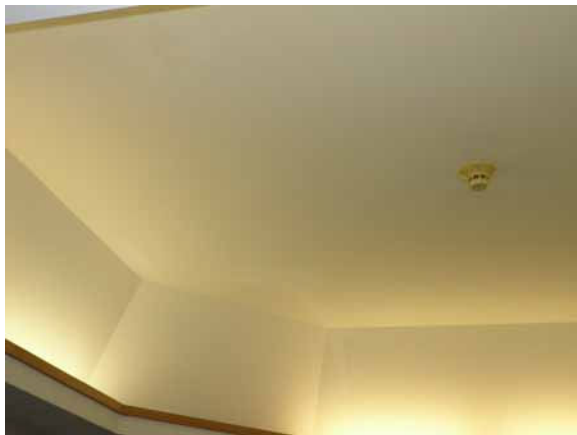
When viewed with the infrared camera, there are obvious thermal air leaks and insulation problems in the sections of raised ceiling in the main hallway.

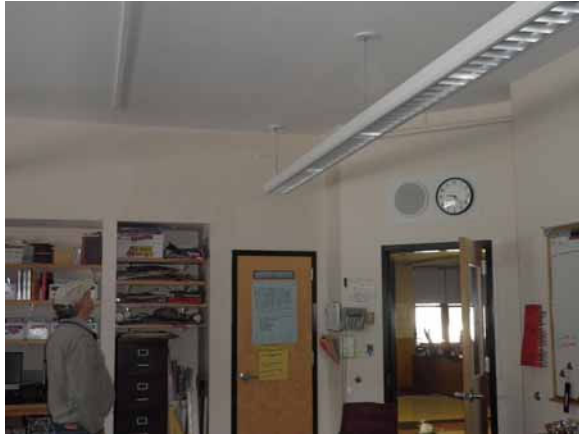
Another interior wall connected to the above attic space. There is most likely plumbing or wiring penetration in the top wall plate that is connecting the interior to the attic.

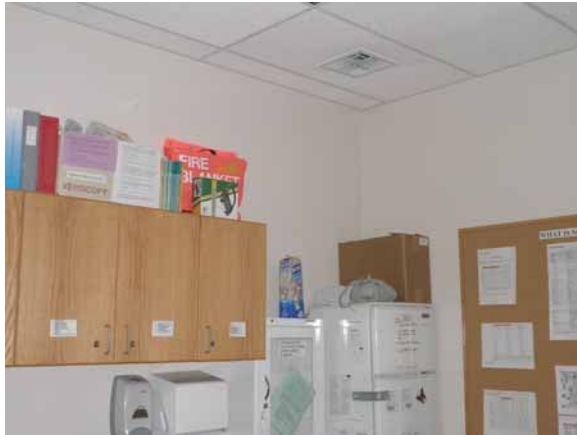
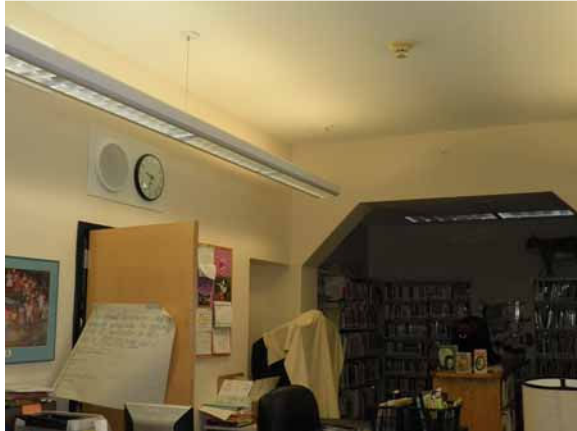
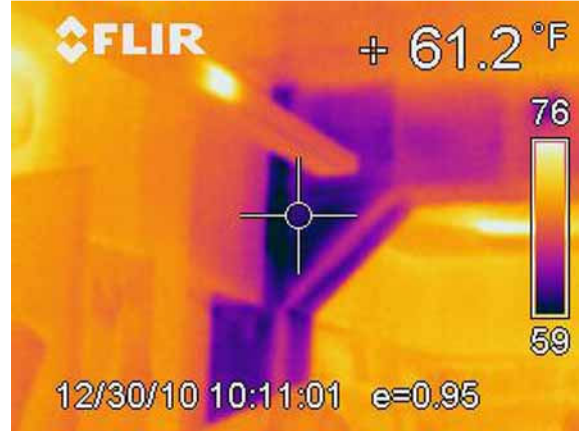
Clearly the bulk of thermal flaws captured by the infrared camera during the interior inspection, document walls that are connected to the attic area. During the blower door test, cold air is being pulled through the air leaks and into the wall cavities. Under normal circumstances, warm air rises up through these areas in much the same way that smoke travels up through a chimney. It is also important to remember that any amount of air that is lost through convection must be replaced. If the building only lost air, it would eventually implode. These air leaks do not lose a constant amount of air, but actually will lose more air when the temperature difference between inside and outside is at its greatest.

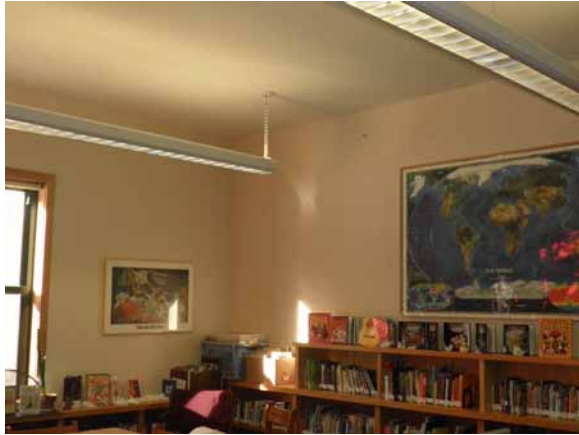
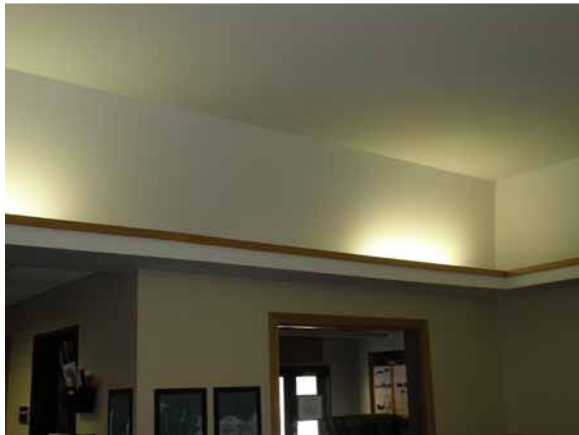
The soffit area is not well insulated and is connected to the above attic space.

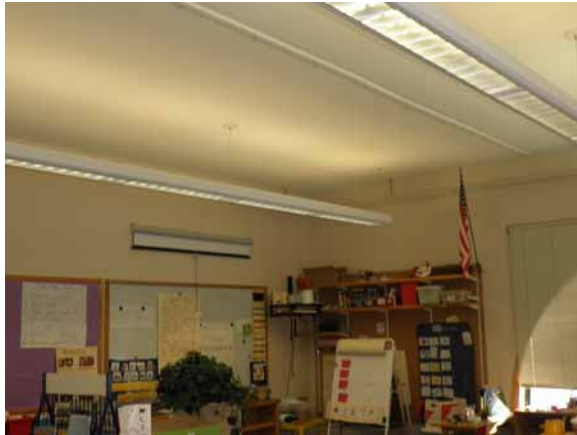
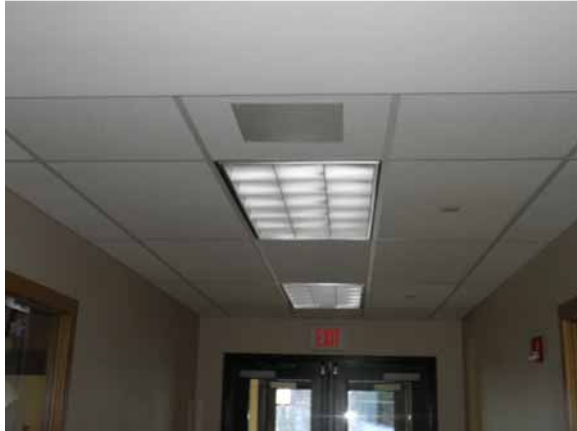
More air leakage through the ceiling tile. This is at the eastern entryway to the school.

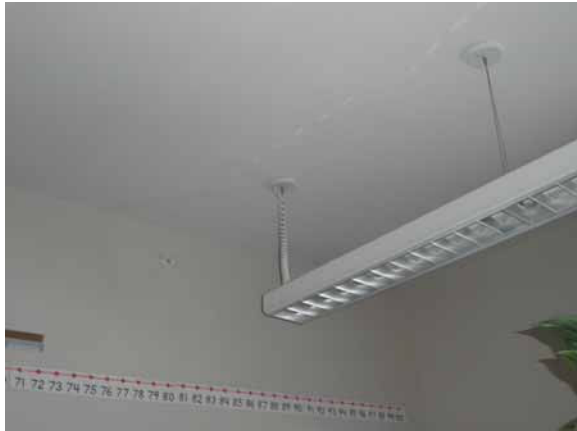
Although it may be difficult to notice the difference, the area above the suspended light appears wet in the image. Also note the cold wall section in the corner of the room.

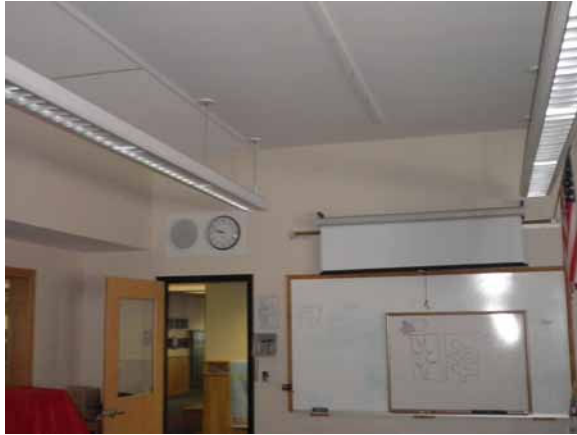
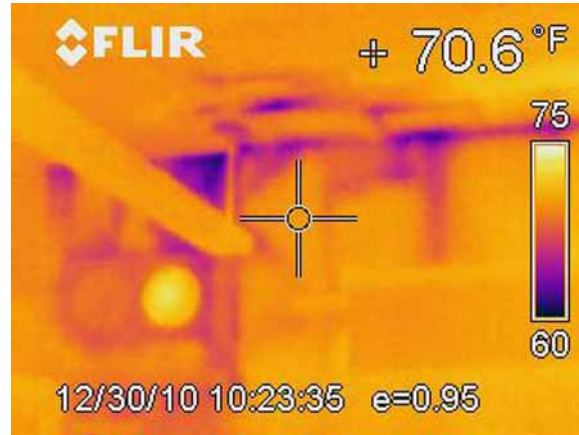
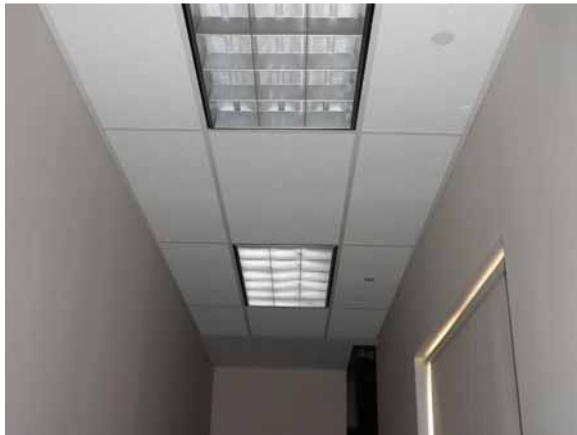
The hallway leading to the stage area is cold and quite leaky. This small roof area is separated from both the gymnasium and school and can easily be accessed by removing several of the ceiling tiles.

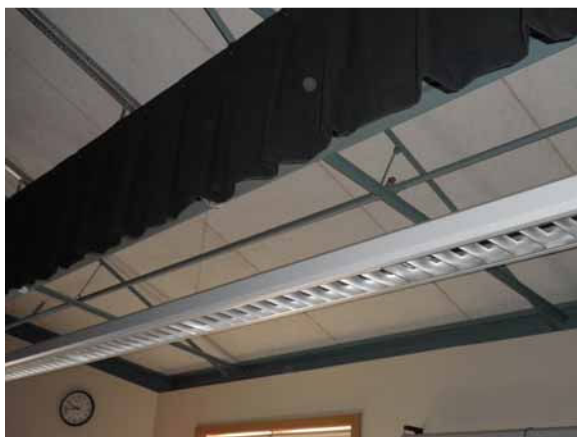
You can see the steel rafters underneath the finished ceiling. These framing members are large and extremely conductive and were easily detected in the exterior images.

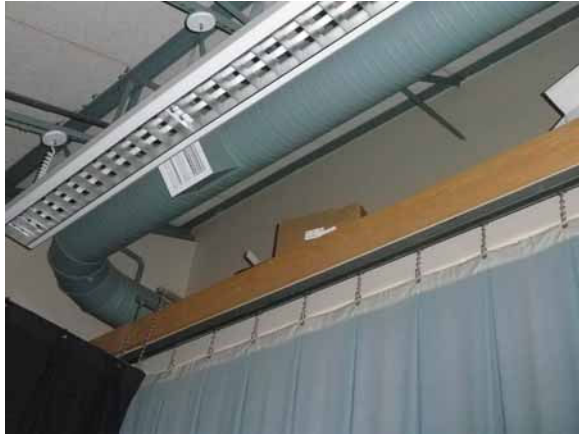
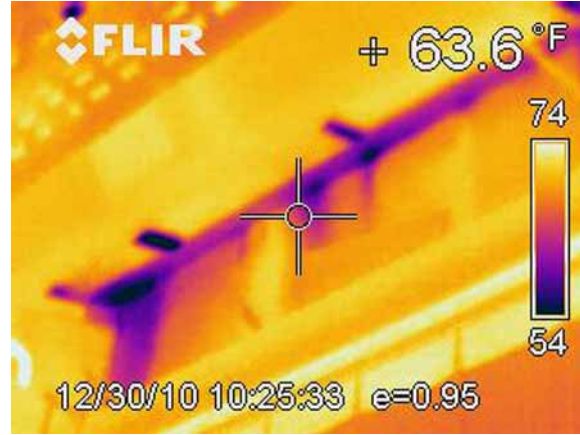
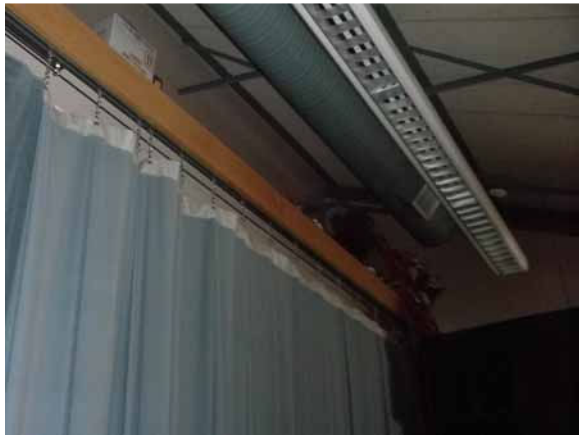
The above two images clearly show the support beam that connects the stage area to the gym wall. This beam is not well sealed, is leaking air, and is also extremely conductive.

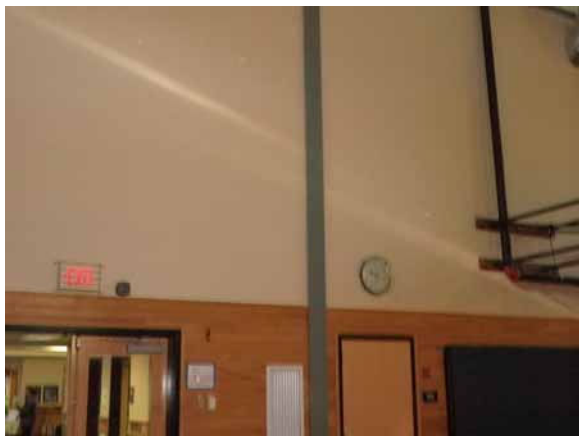
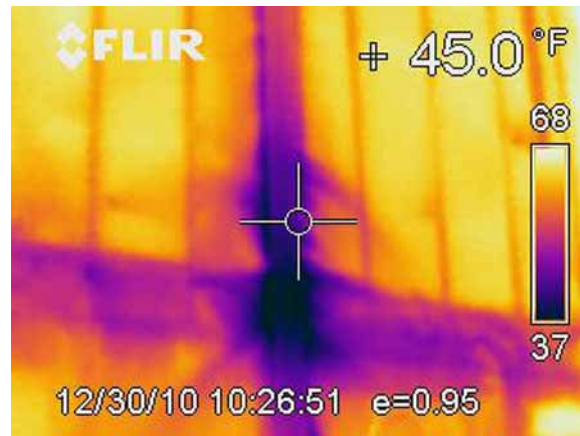
# Energy Analysis - Warwick Elementary School

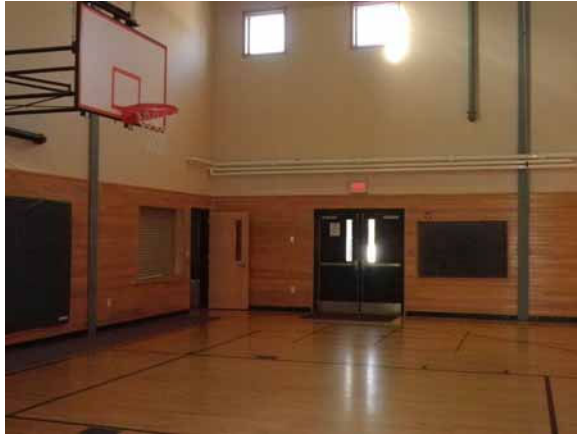
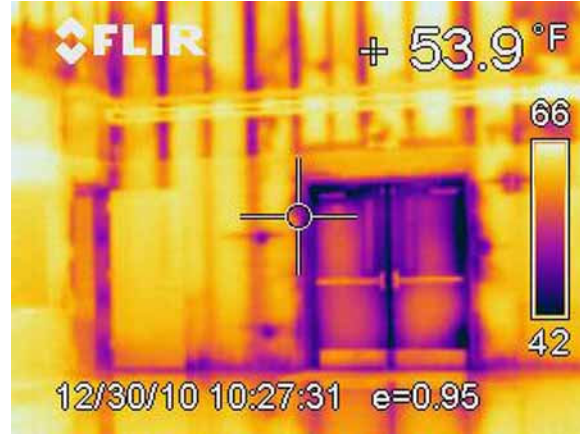
The steel framing in the gym is far more conductive than the framing members in the exterior walls of the school. The large beams and posts that support the building are highly conductive and in many areas are not well air sealed. The air leakage is likely due to minor settling or shifting of the building after it was constructed.

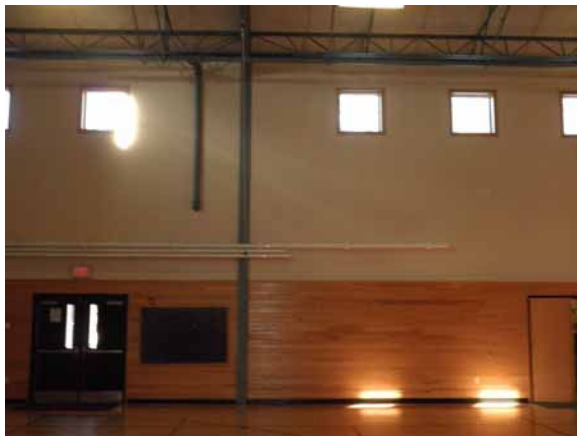
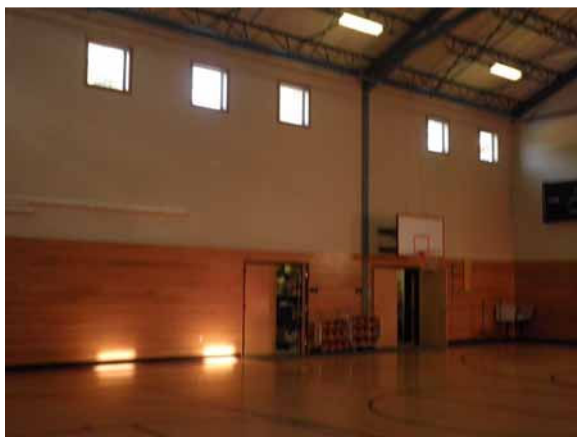
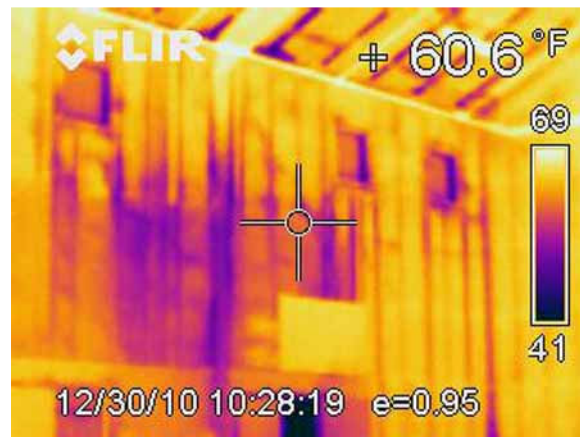
## Energy Analysis - Warwick Elementary School

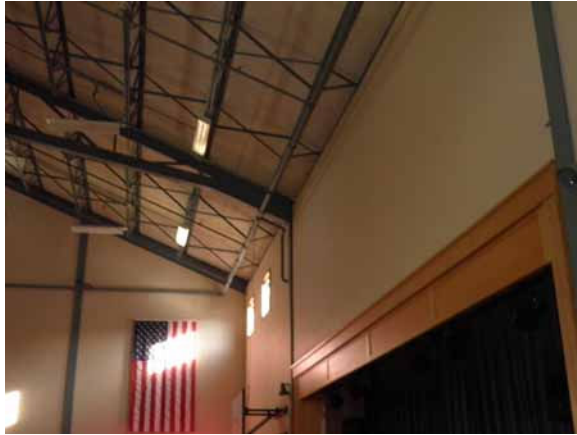
The air leakage along the top of the exterior wall and ceiling junction reinforces the information from the exterior images. This area is not well air sealed and is contributing to heat loss and to uncomfortable conditions in the gym and stage areas.

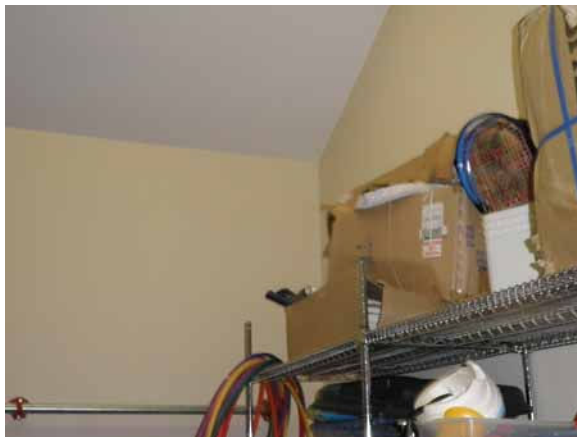
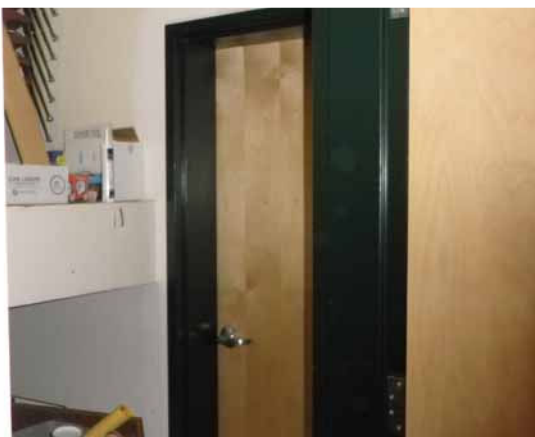
This door leads to the generator room, which is essentially outside the thermal envelope. For both safety and thermal efficiency reasons, door and wall should be well insulated and air sealed.

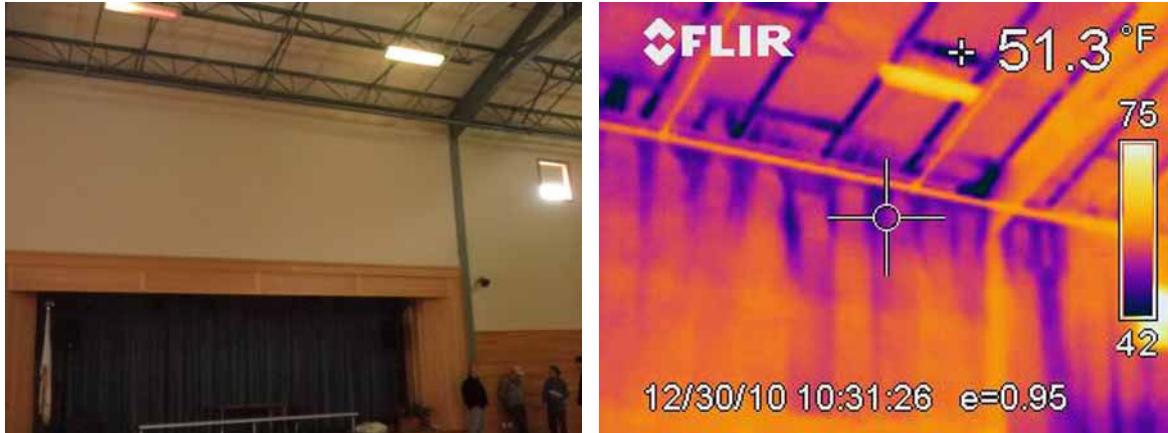
This shot of the east side gym wall clearly shows the air leakage at the top of the wall where the steel strut joins the wall and roof assembly.

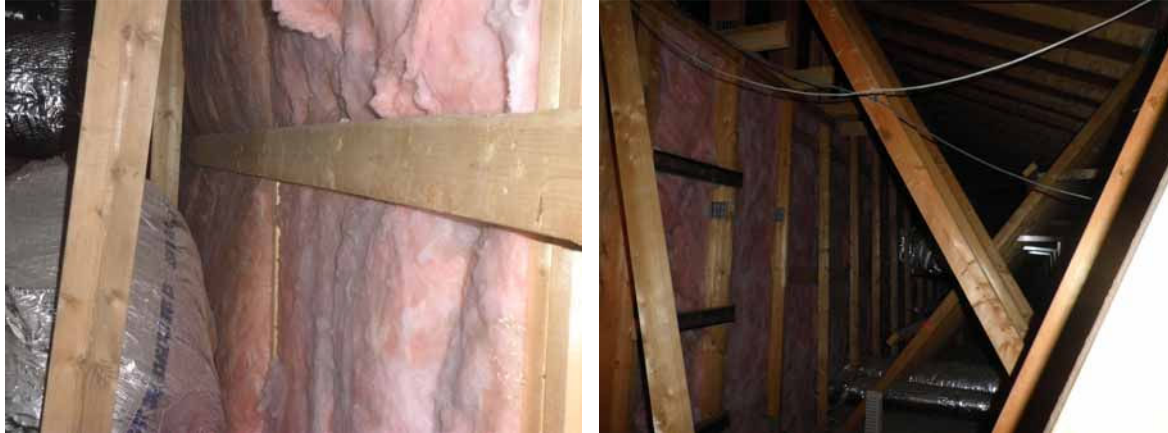
These images were taken from the backside of the mechanical room hallway. All vertically installed fiberglass must be covered on all six sides with an effective air barrier in order to attain its stated/intended thermal performance.

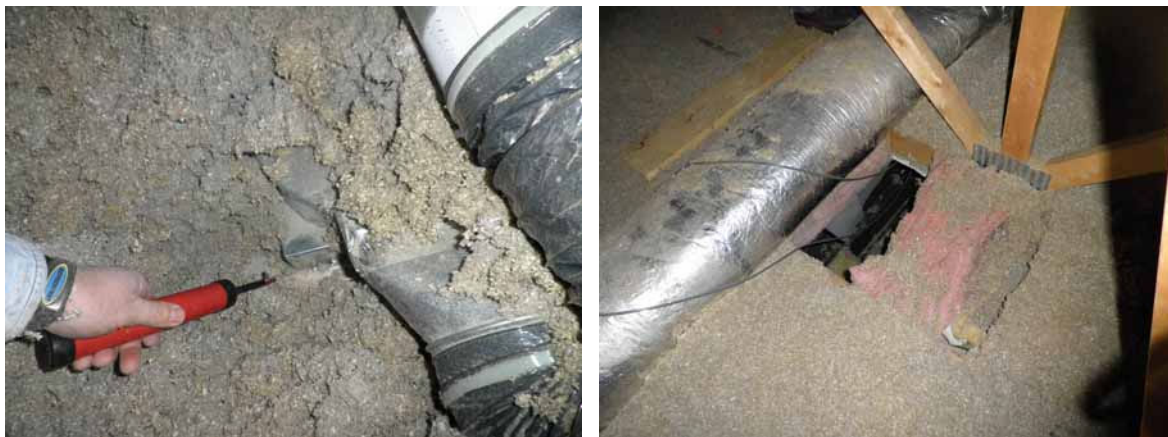
This duct has been stepped on and flattened (left). It goes to an interior fan which is leaking air around its perimeter. The right photo shows a problem that is common in many schools, hospitals and other public buildings. Access through the thermal boundary is attained by a trades person, wires, plumbing, or fire suppression equipment is installed, and the insulation is left to the side, and the hole is left wide open.

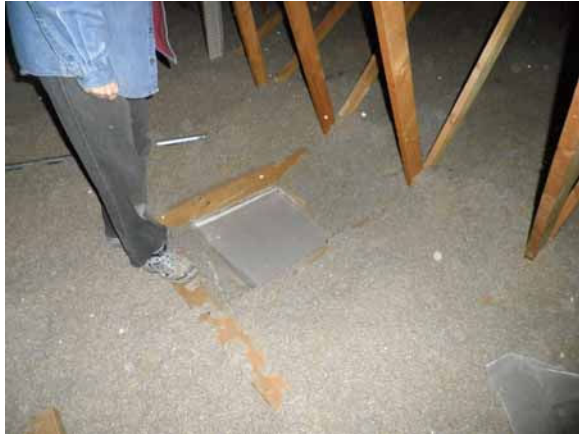
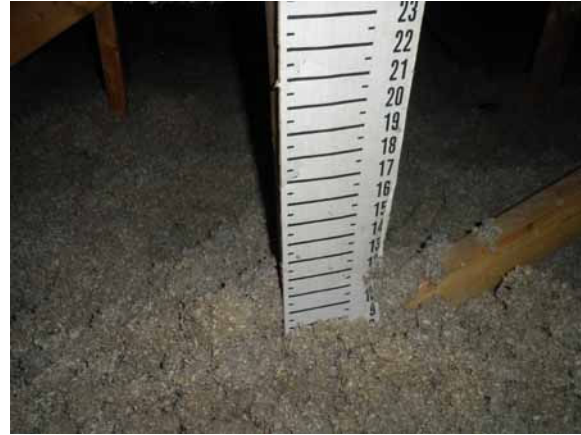
There are numerous holes in the attic floor which connect the outside to the building's interior conditioned space. The cellulose insulation is uneven in its distribution and depth. The average depth of the cellulose is 8 inches which at best (if it were in direct contact with an effective air barrier) would be an R-value of 29.6

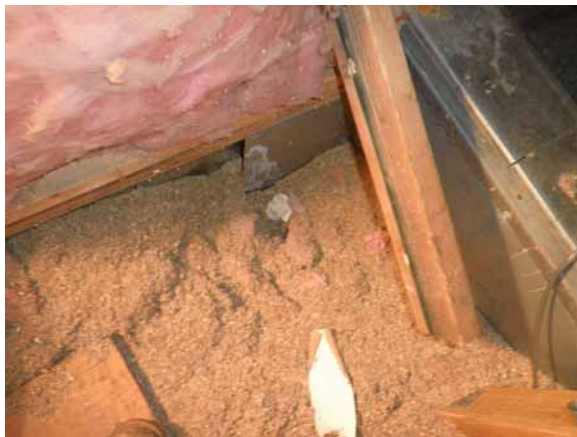
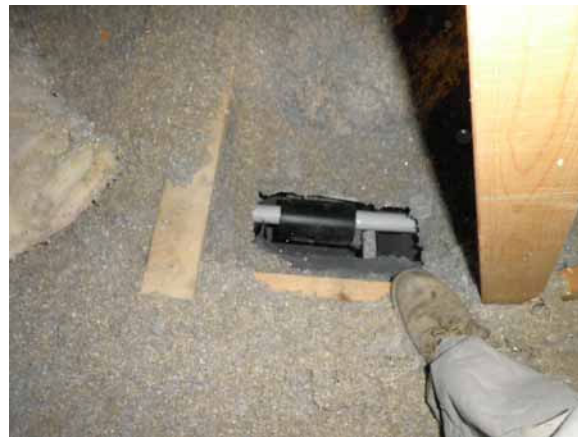
The thermal flaws in the conditioned attic/mechanical room area do not end with the uncovered vertically installed fiberglass and the numerous holes linking the space to the outside. The left side picture shows that the bottom floor of the area is not blocked off, allowing a connection to the outside underneath the entire length of the floor.

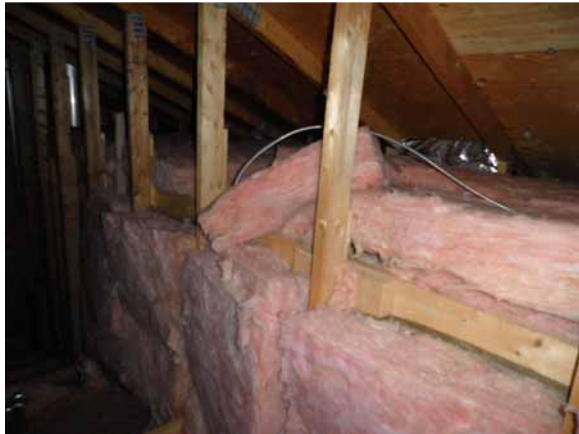
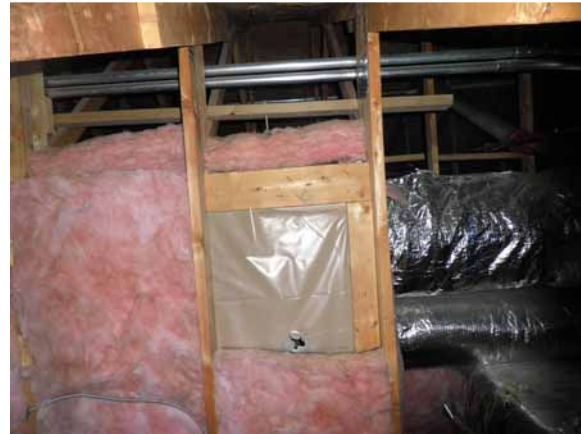
The above two images show the exterior side of the hallway connecting the boiler room to the conditioned/insulated section of the attic. Again, all vertically installed fiberglass must be covered with an effective air barrier on all six sides. Significant gaps and holes in this "thermal blanket" add to heat loss and decrease the performance of the insulation.

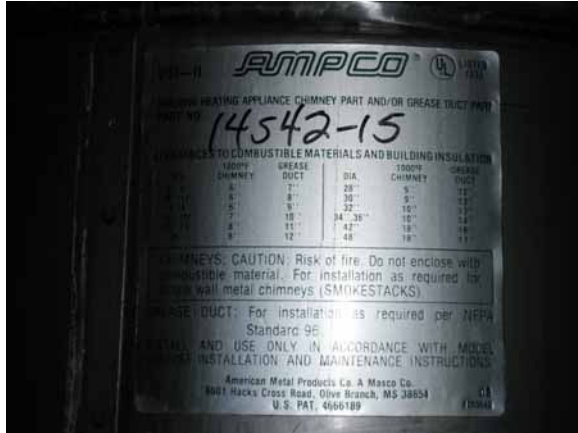
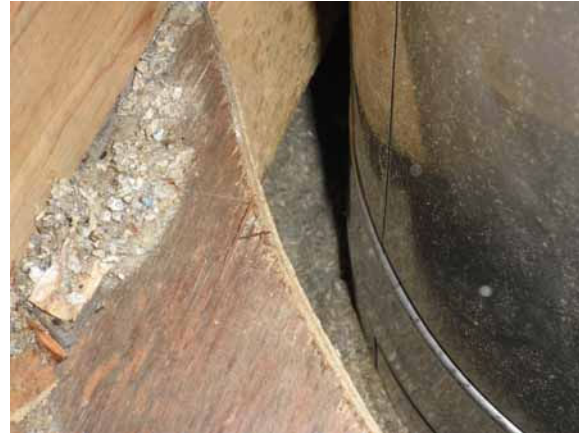
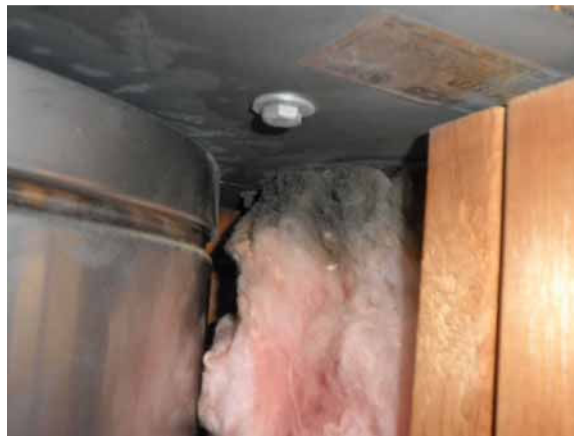
The above photographs are of the metal chimney for the boilers. According to manufacturer specifications, this 14" diameter pipe should have a minimum clearance to combustibles of 6". This code violation represents a health and safety concern which under BPI (Building Performance Institute) protocol receives top priority.

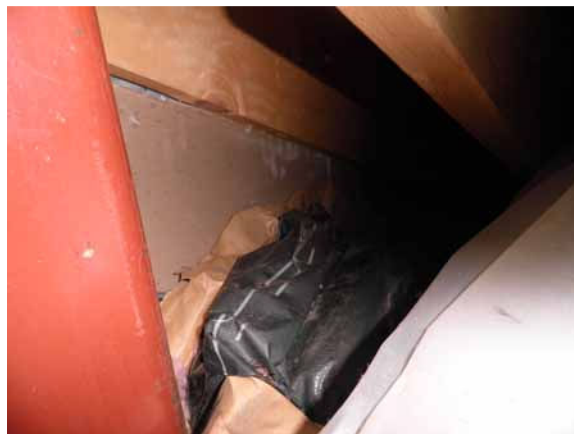
On the other side of this wall is a space between the flat hallway ceiling of the back stage access, and the roof. This gap in the thermal boundary helps to explain the poor thermal performance of the hallway ceiling.

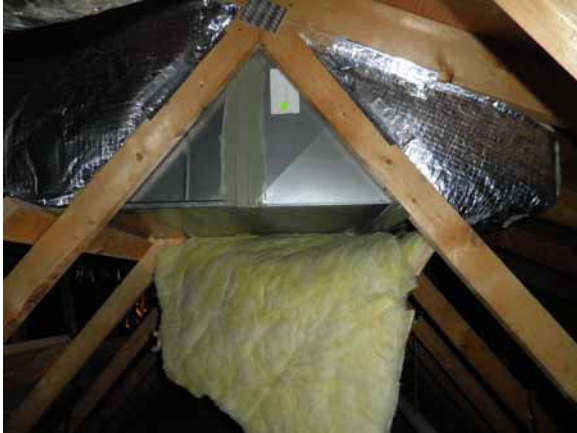
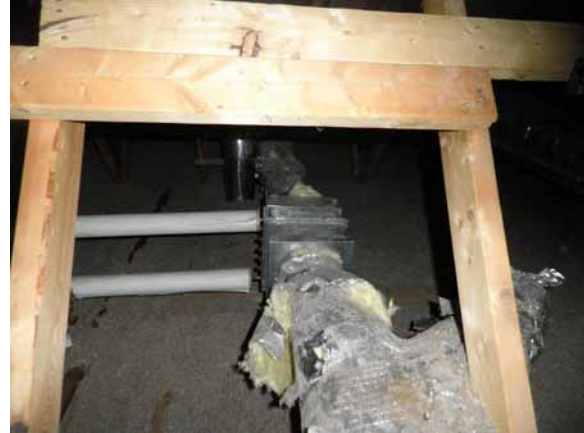
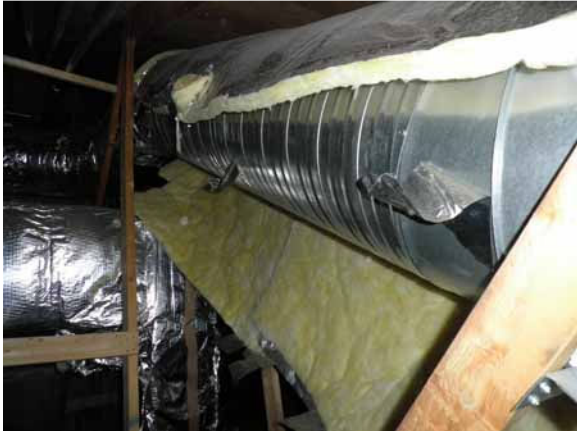
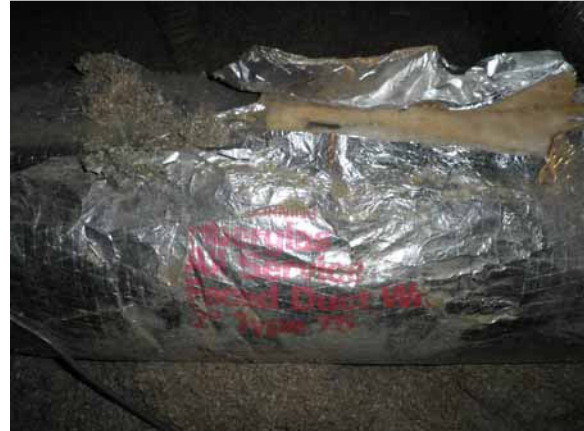
More photographs of the numerous problems with the heating distribution system. All exposed joints should be sealed with mastic if they are not already, and missing insulation should be repaired or replaced.

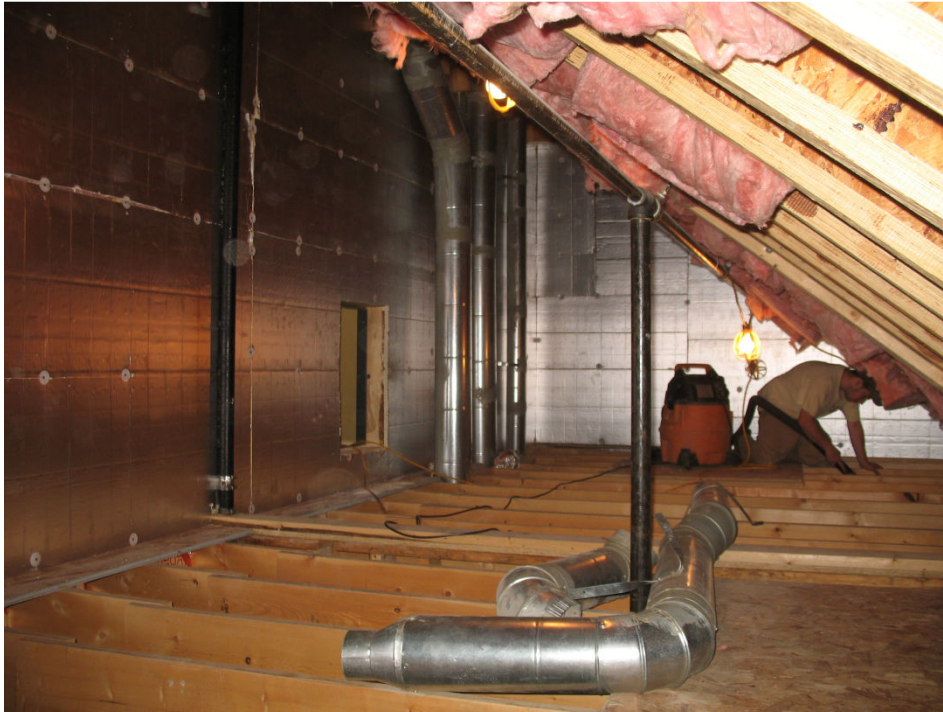
*Vertical walls sealed and insulated with polyisocyanurate rigid foam board and sealed at the Grand Summit Lodge Mt. Snow. The attic floor is receiving final clean up prior to insulating with 2" of spray applied foam and cellulose.*

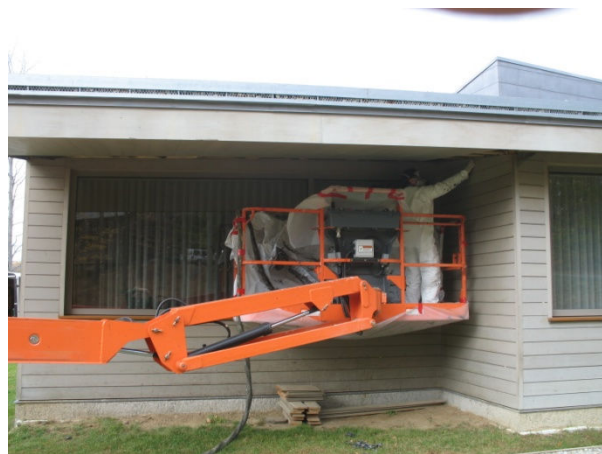
*Accessing and spray foaming the metal struts at the Putney Schools new performing arts building.*
